AERIAL VISUAL CONDITION SUMMARY

# Roof Inspection Report

Coral Street Residence, Cairns Region

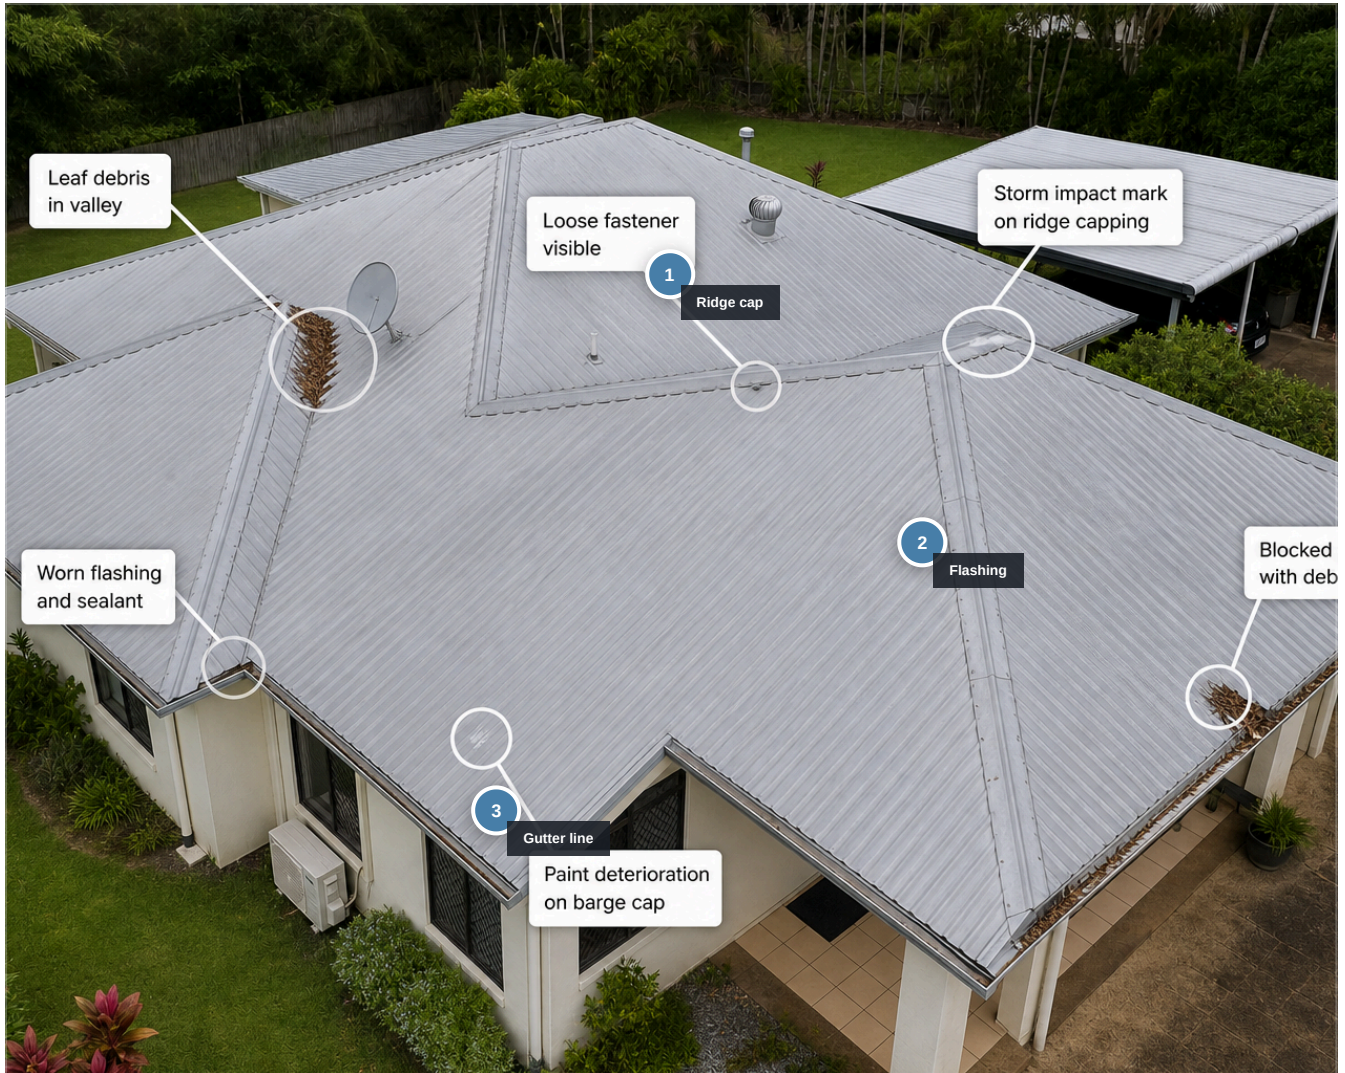
## Ridge cap

A small area has been marked for closer trade review. The image alone does not establish whether a defect exists.

## Flashing detail

The junction is visible from the aerial angle and would benefit from an on-roof assessment if there are active leak concerns.

## Gutter line

Leaf material appears visible along part of the gutter line. Safe cleaning and condition assessment should be completed by a suitable contractor.
