AERIAL VISUAL CONDITION SUMMARY

# Roof Inspection Report

Coral Street Residence, Cairns Region

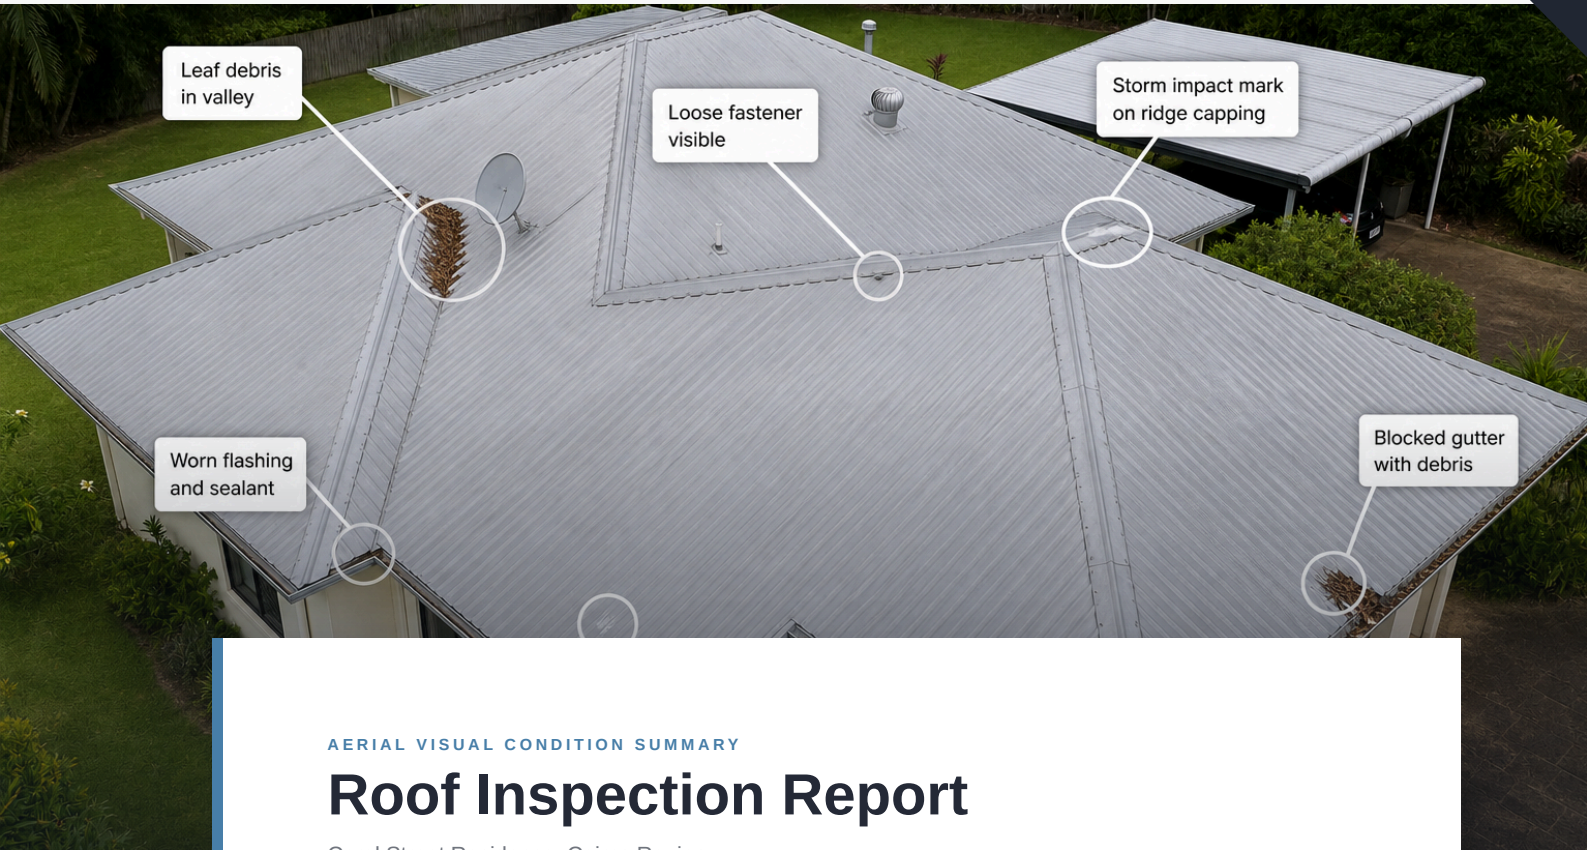
A small area has been marked for closer trade review. The image alone does not establish whether a defect exists.

The junction is visible from the aerial angle and would benefit from an on-roof assessment if there are active leak concerns.

Leaf material appears visible along part of the gutter line. Safe cleaning and condition assessment should be completed by a suitable contractor.
